## Case Study

### Problem 1 – Fouled Air Scrubber System

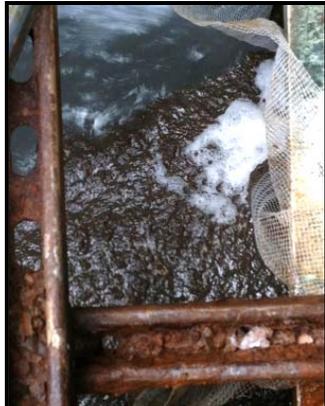
An air scrubber system located in a high ammonia environment with a low pH (2.8) water and conductivity of <1000 was exhibiting significant biomass build-up. When screens were pulled for cleaning, the mesh contained a thick layer of bio-mass. (Image 1) In addition, the system's recirculating pump exhibited operational problems and the pH probe was typically fouled.

Image 1: Before BCP™ 1015 treatment: foam & biomass material collected at the screen

### Solution – Clean-up with BCP™ 1015

The air scrubber system was cleaned up over the course of 7 days. The system was dosed 2 times a day with BCP™ 1015. When the screen was pulled, there was little bio-mass and the area was much cleaner. (Image 2) The customer noted less trouble from the recirculation pump and the pH probe needed significantly less cleaning.

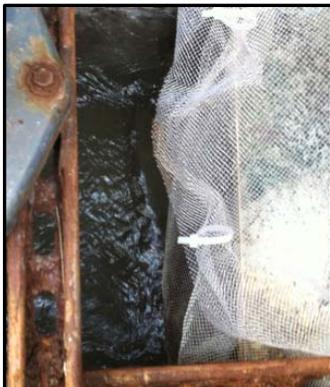
Image 2: After BCP™ 1015 treatment
