In Injection Molding Facility Sludge (Bio-organic deposit) Control

Case Study

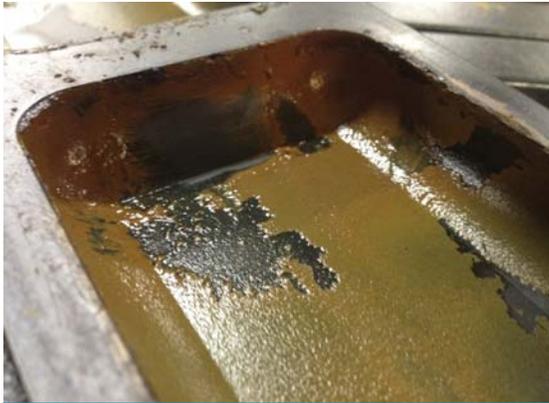
Image 1: Bio-organic deposition

After only a few weeks, the chiller efficiency dropped to the point that it could not maintain chill water temperature, and would fail due to high head pressure, attributed to surface fouling. The existing water treatment program failed to keep the surfaces clean of fouling. Chiller failure continued. The chiller issues caused significant production problems, including increased parts failure rate, product delays, and maintenance costs. In addition, chiller surfaces were significantly fouled as shown, and thus, production rate was further impacted.

It was determined that the cause of fouling was related to a microbial produced coating (biofilm) on the heat exchange surfaces. Biofilm is created by bacteria so they can attach to surfaces, and reproduce more efficiently than if freely floating (planktonic). This “slime” (biofilm) prevents or limits biocides’ ability to kill the bacteria. A microscopic layer of slime reduces heat transfer rates which results in loss of process temperature control. By the time such layers are visible, the problem is very severe.

Although studies on the bulk water showed very few microorganisms present, it was clear that significant slime

remained on the heat transfer surfaces. The current biocide program was effective in the bulk water, **but was not effective in controlling surface fouling.**

Immediately after cleaning the condenser, BCP™ 1015 (trademark of AMSA, Inc.), an effective penetrating agent, dispersant, and corrosion inhibitor, was used at dosage levels of 12 ppm (active) once per week. One hour after the addition of BCP™ 1015, the biocide was added (few ppm active).

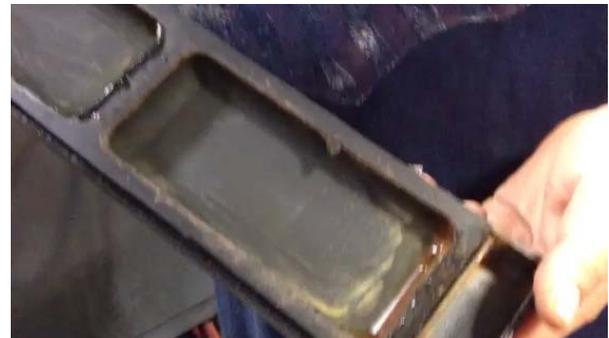
Image 2: BCP™ 1015-treated chiller surfaces free from bio-organic deposition

- Prior to the BCP™ 1015 program, the chiller could stay on line no more than about 7 weeks before shutdown and cleaning.
- **Using BCP™ 1015, there has been no downtime due to condenser fouling.** After several months, inspection showed the surface to be absolutely clean with no indication of organic deposits.

Shortly after the addition of BCP™ 1015, a brownish foamy slurry developed. Slurry formation is related to the cleaning action and is proportional to the amount of deposits removed. Once the surface is clean, slurry formation stops.

BCP™ 1015, used on a consistent basis (maintenance mode vs cleanout mode), cleans surfaces and reduces the amount of biocide needed.
